**UNITED STATES ENVIRONMENTAL PROTECTION AGENCY**

Re: Notice of Violation  
RCRA Compliance Evaluation Inspection – Mid-City Plating Company  
EPA I.D. No.: IND 006 049 456

# Photographs for Mid City Plating Company CEI 6/22/2010

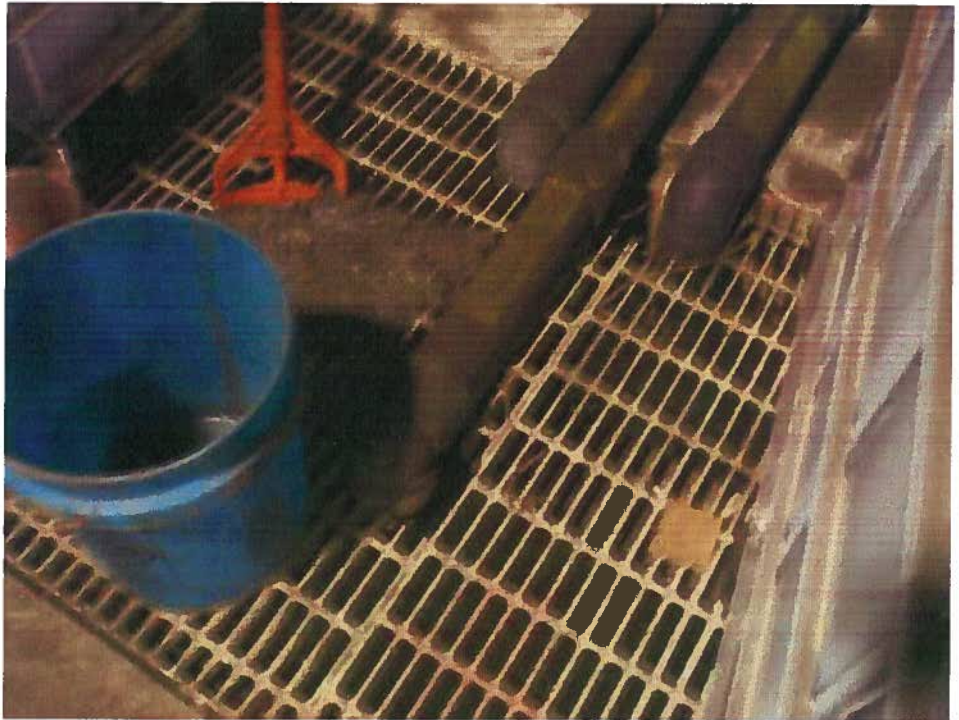
Hanson Plating Machine trench. Waste water from plating line was collected in trench and was manually pumped into WWT unit. Line had not been in operation since January 2010.

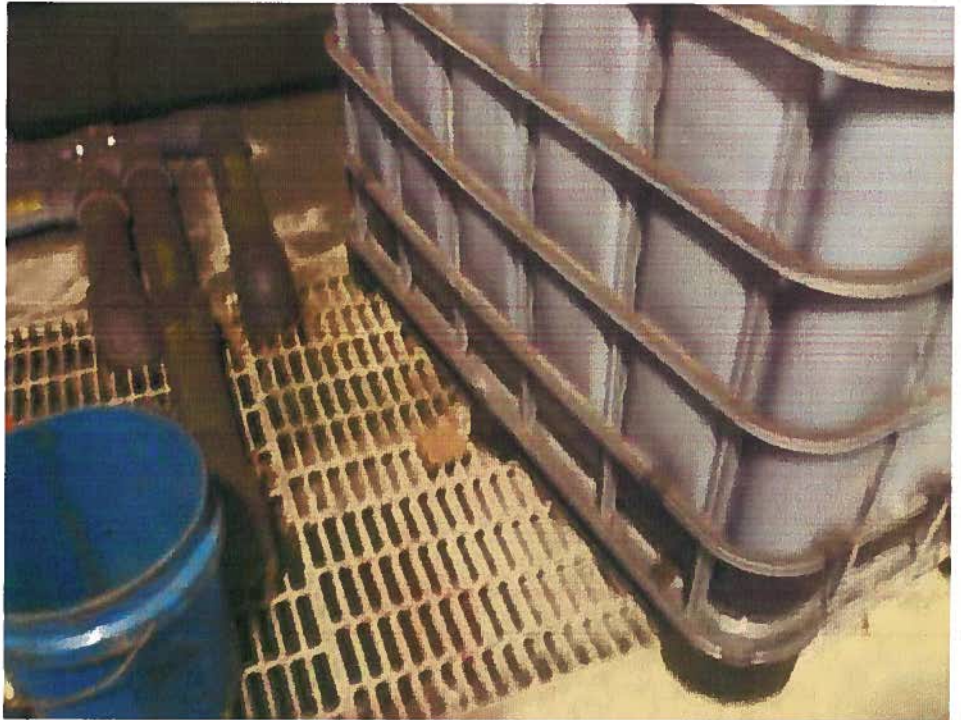
Hanson Plating Machine trench. Waste water from plating line was collected in trench and was manually pumped into WWT unit. Line had not been in operation since January 2010. Liquid was located inside of trench at time of inspection.

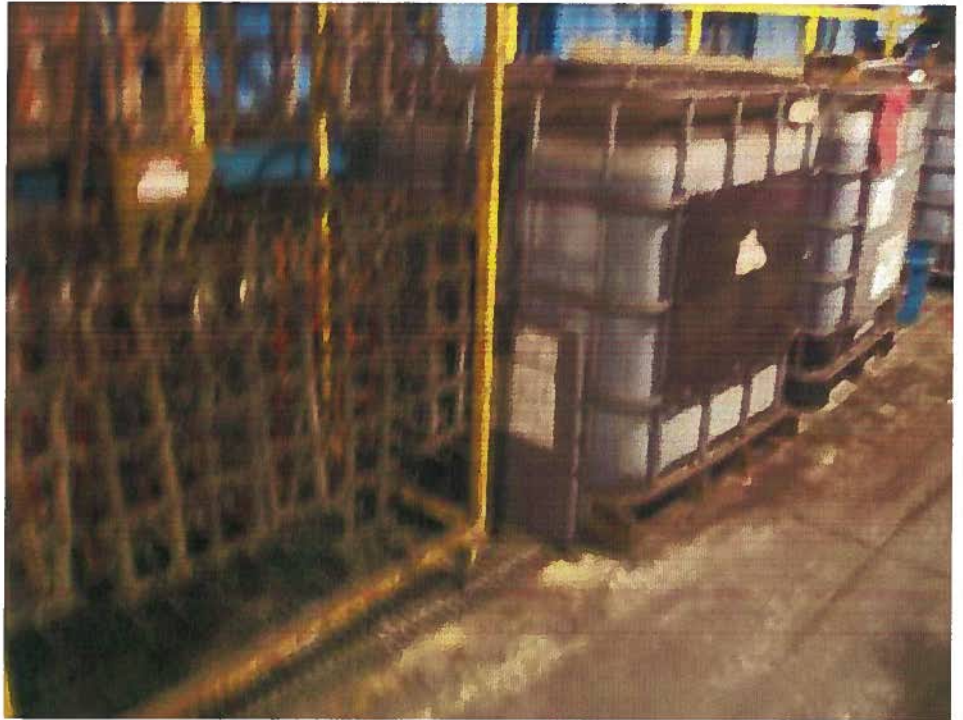
Hanson Plating Machine. Materials were being stored inside of totes located near plating line. Plating line had not been used since January 2010.

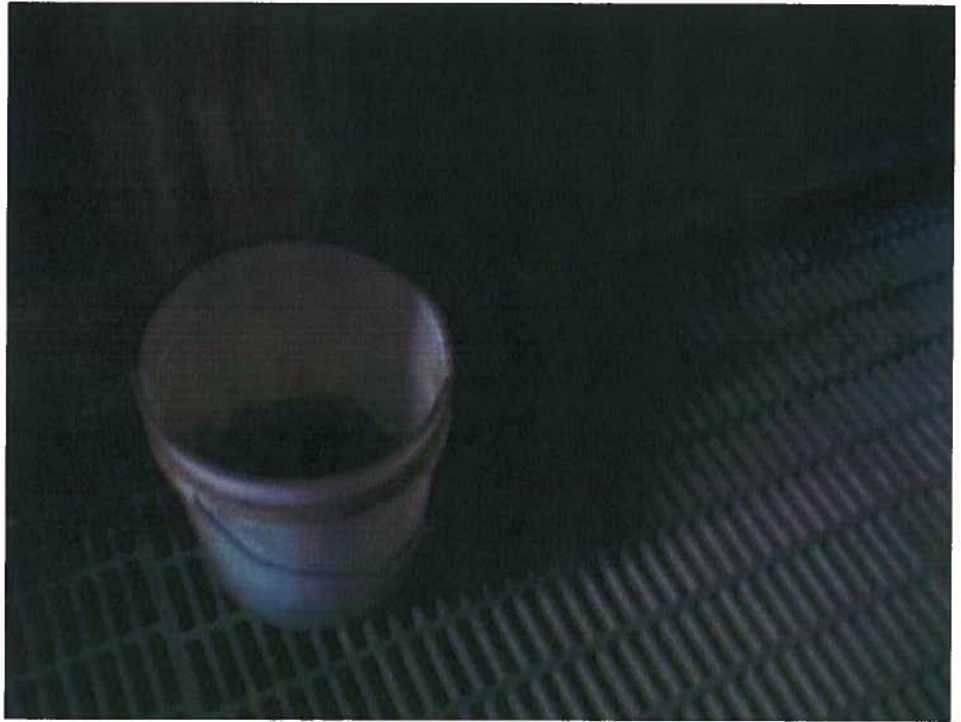
identify the hazards or contents of the materials. The locations and types of containers were: 1) one open 5-gallon bucket located on a trench near the E-coat line, containing an un-identified liquid; 2) four open 5-gallon buckets located on the floor near the E-coat line, containing an un-identified liquid; 3) one open 5-gallon bucket located on a pallet near the raw material storage area, containing an un-identified liquid; 4) a grated pit located near the WWTU waste water storage totes, containing a 4-inch thick un-identified solid material; 5) one orange plastic pallet located near the WWTU waste water storage totes, containing an un-identified liquid; 6) one plastic bath located near the former Barrel Row line plating process, containing an un-identified liquid; 7) a containment pit located below the zinc plating line and on the floor, containing a solid material; and 8) the floor throughout the facility, containing unidentified liquids.

Open bucket of material located on trench near the E-coat line. E-coat line was in operation 1 or 2 shifts per month.

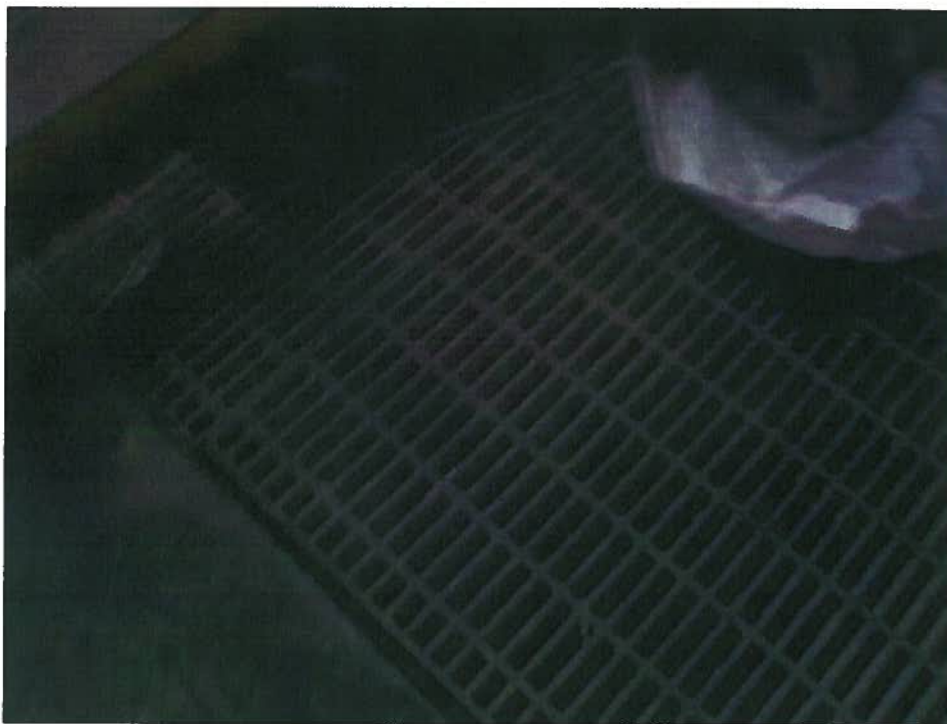
Trench located near E-coat line. Trench collected waste water to be pumped into WWT unit periodically.

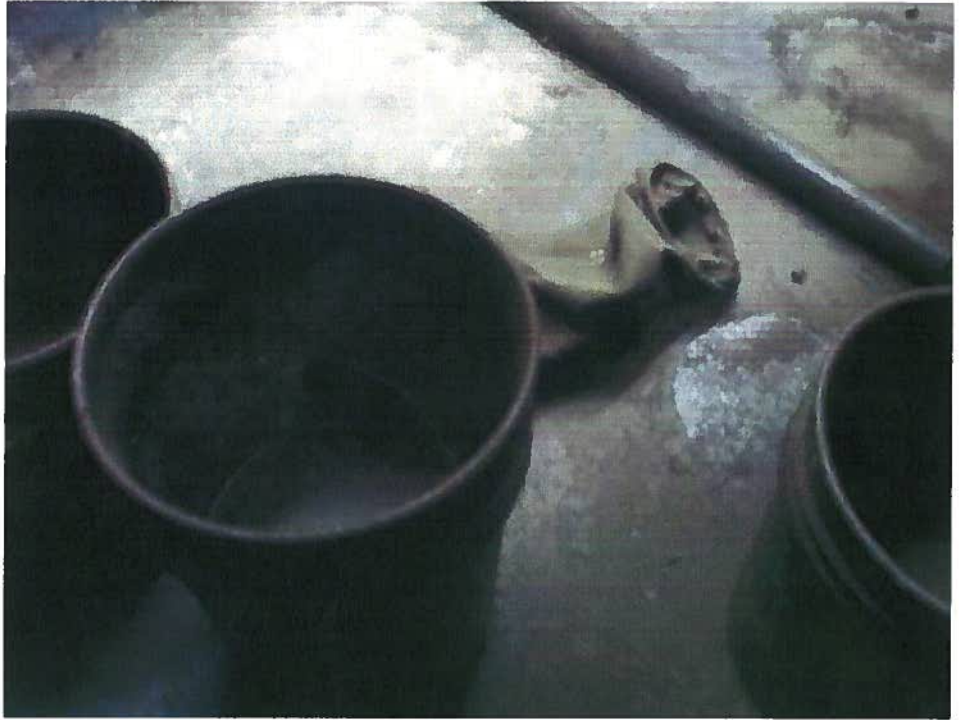
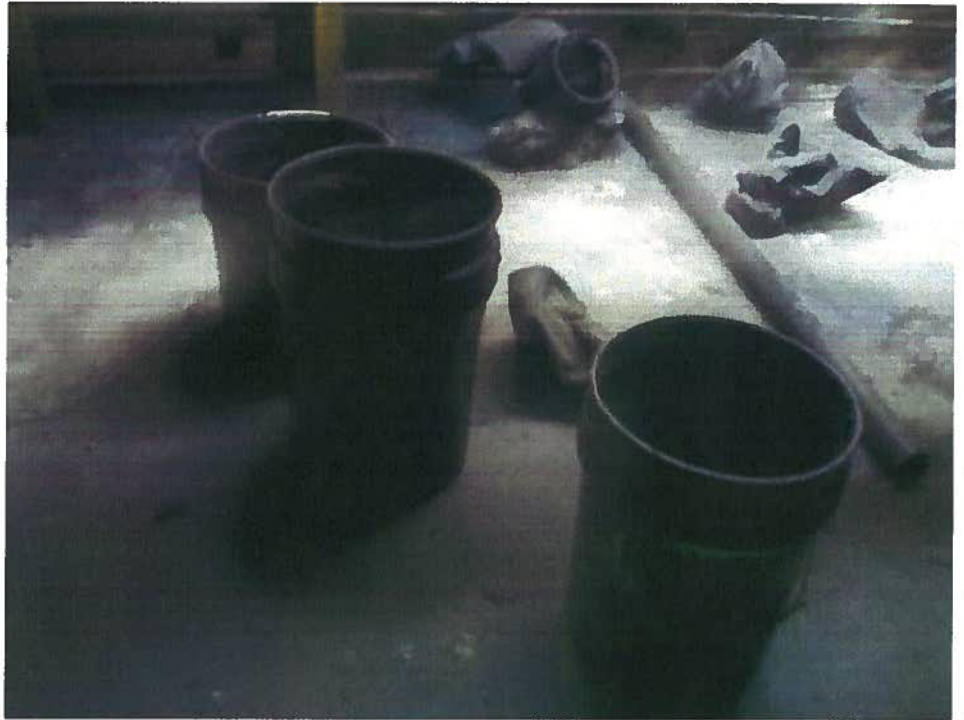
3 open buckets of un-identified material were being stored on the floor near E-coat line. Spider webs/cob webs were located inside of buckets.

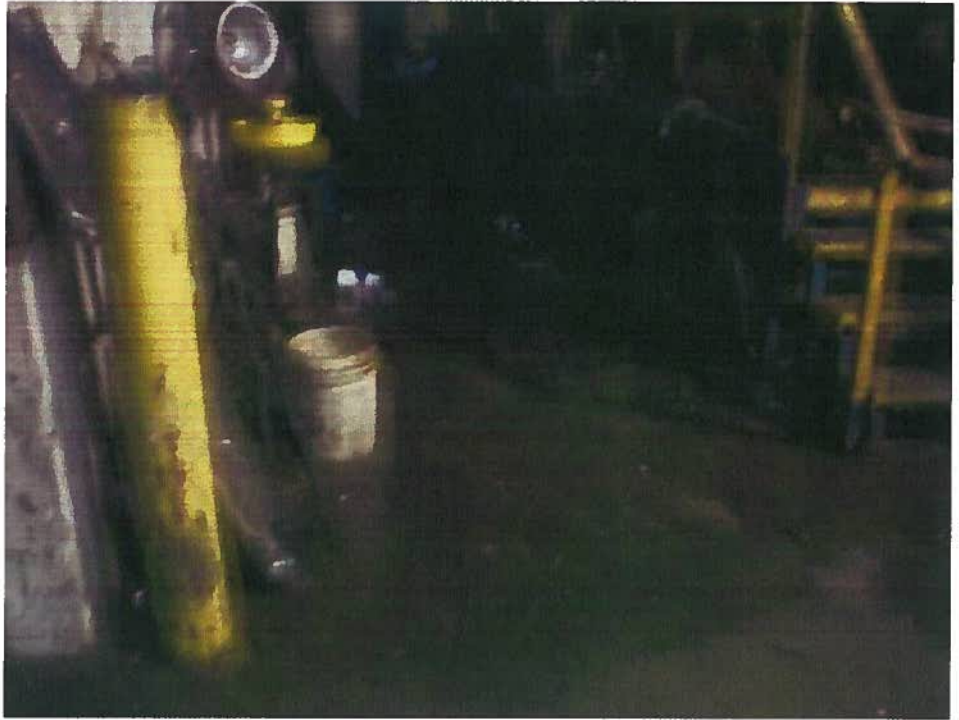
Liquid was located on the floor near plating line. Open bucket of material was also located in this area.

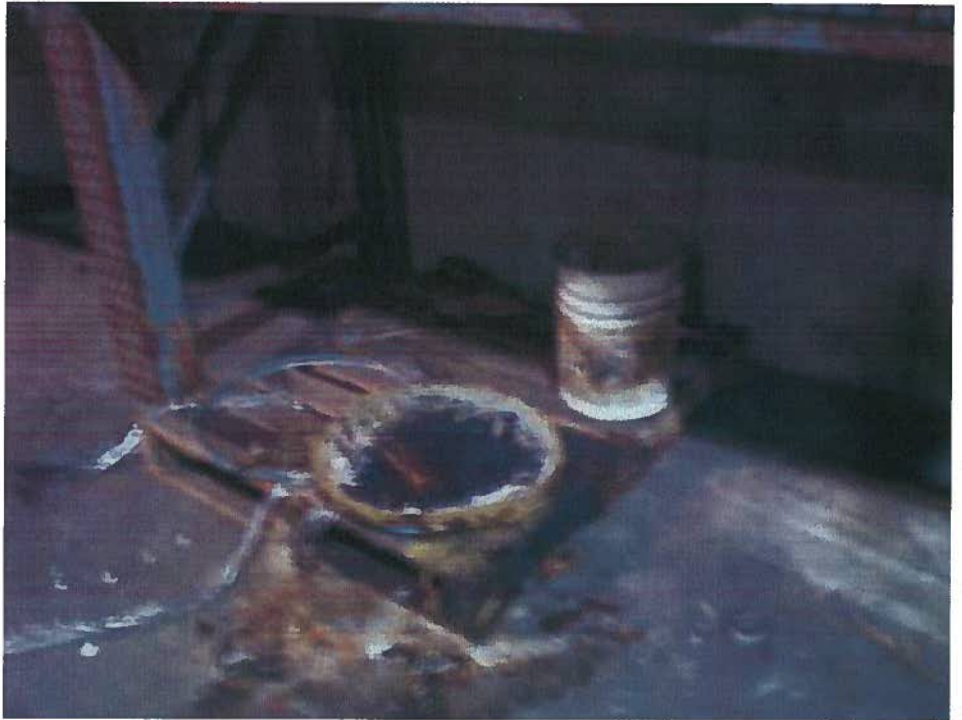
An open bucket, containing a material, was being stored in the raw material area on a pallet. A corroded metal lid was also being stored on the pallet.

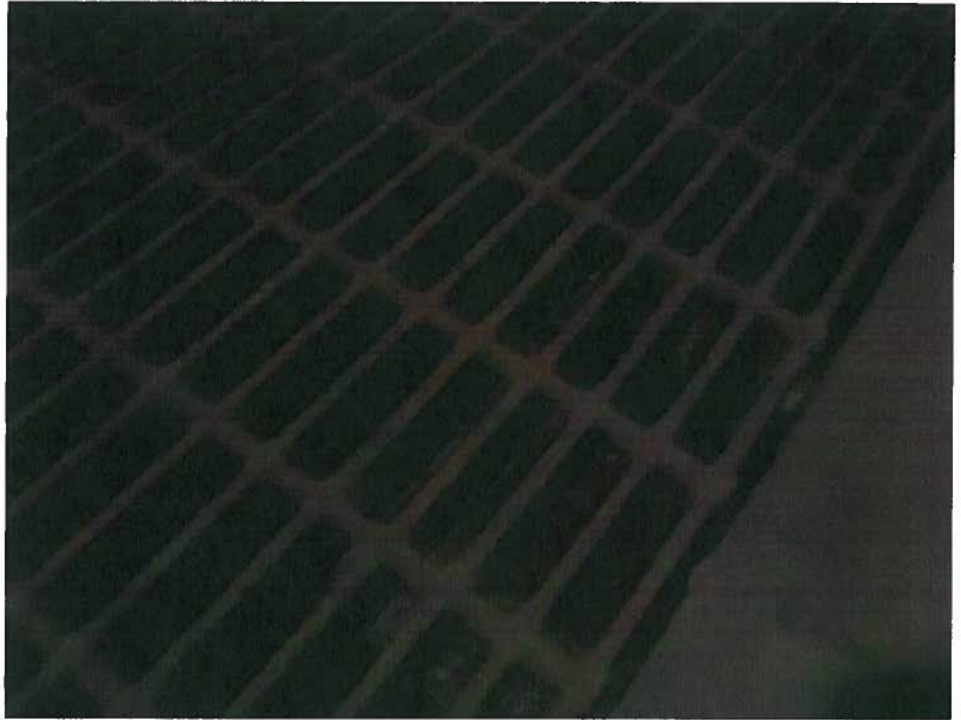
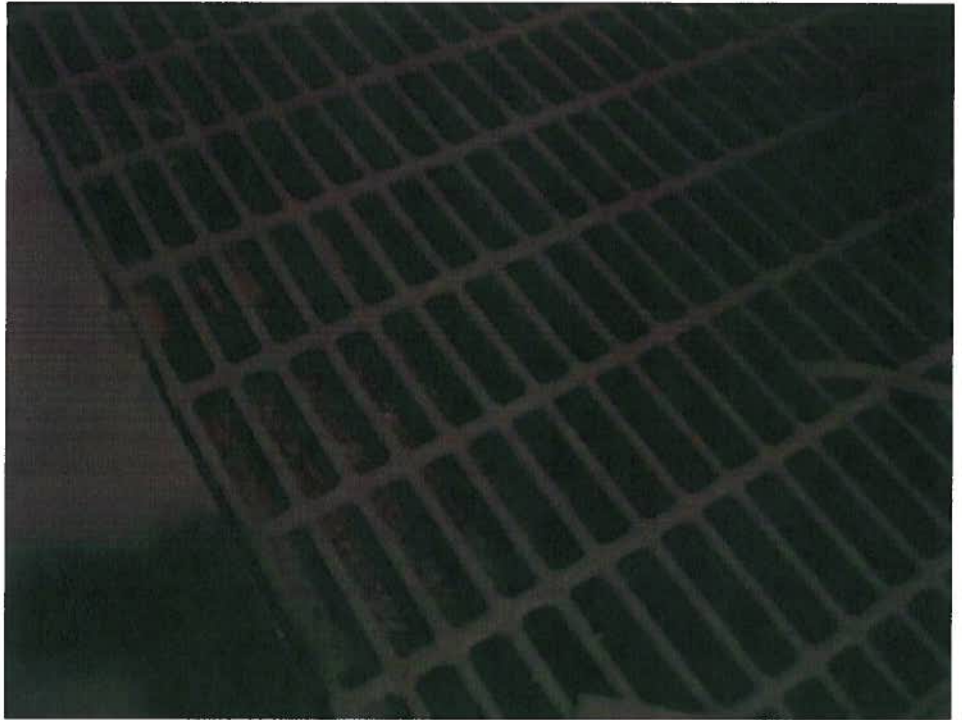
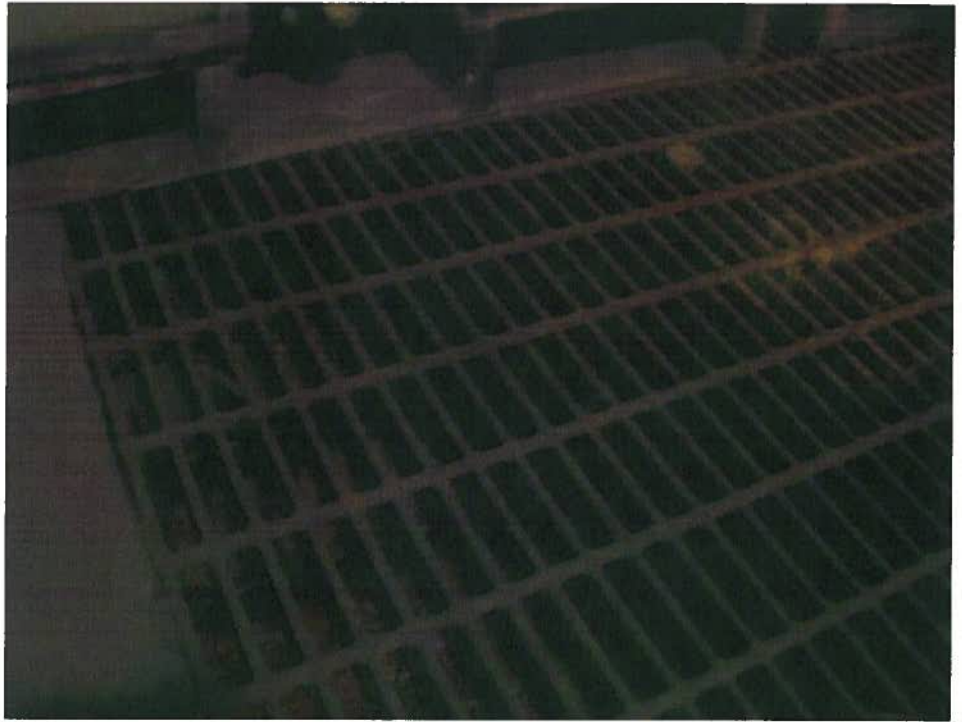
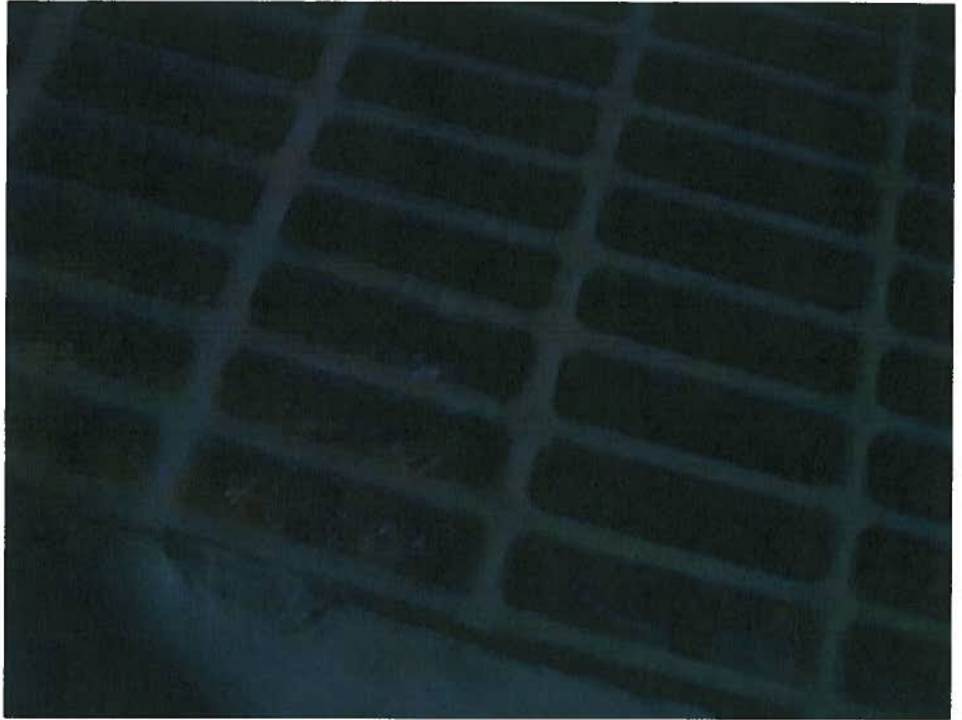
A pit, with a grate, was located near the WWT unit waste water storage totes. A 4-inch thick un-identified solid material was located in the bottom of the pit.

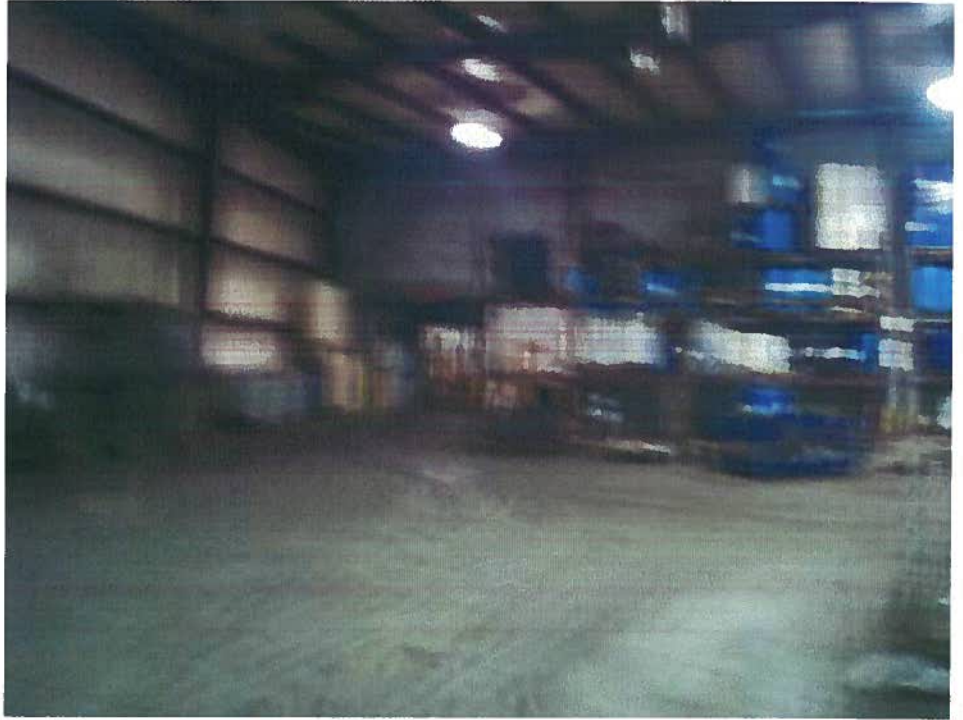
3-tiered shelving unit storing 55-gallon containers. Containers were described as empty.

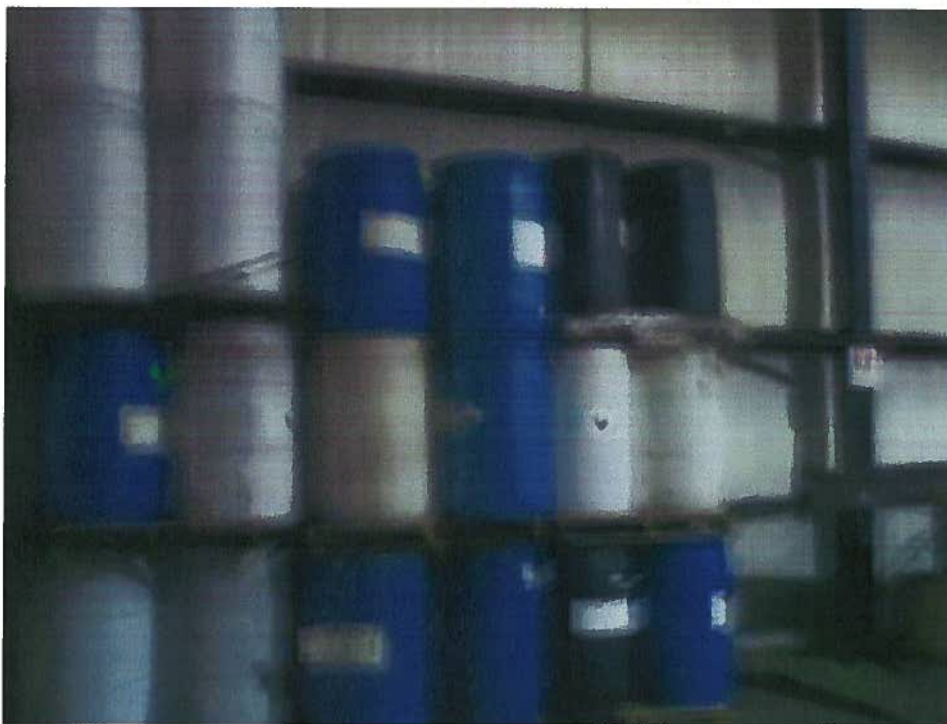
55-gallon containers were beings stored along the South wall. The containers were described as either empty or containing "working solutions."

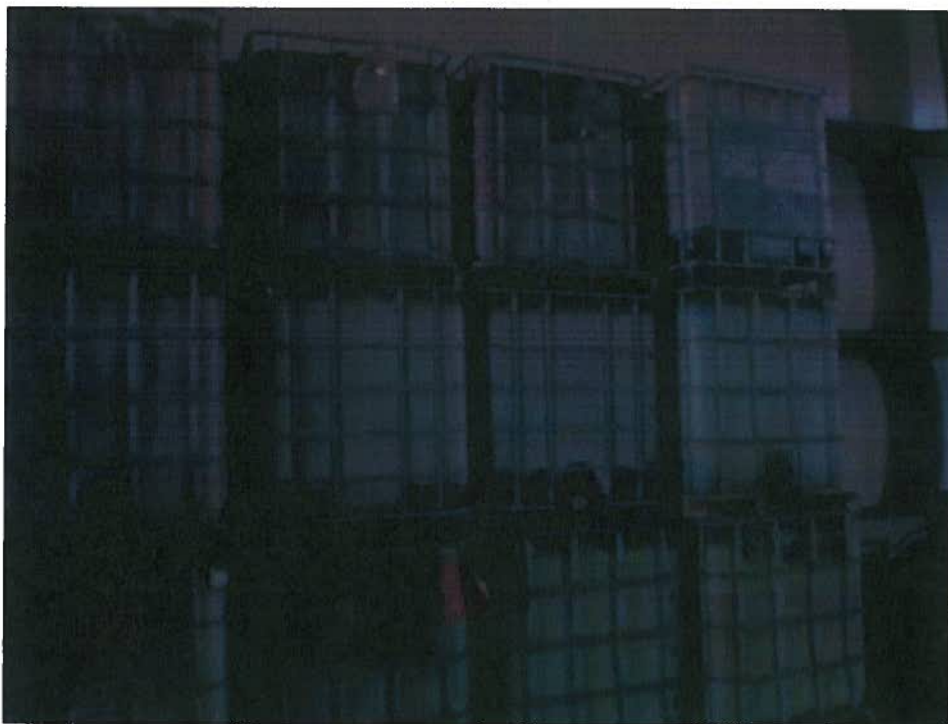
Totes were being stored and stacked along South wall. The totes were storing "working solutions."

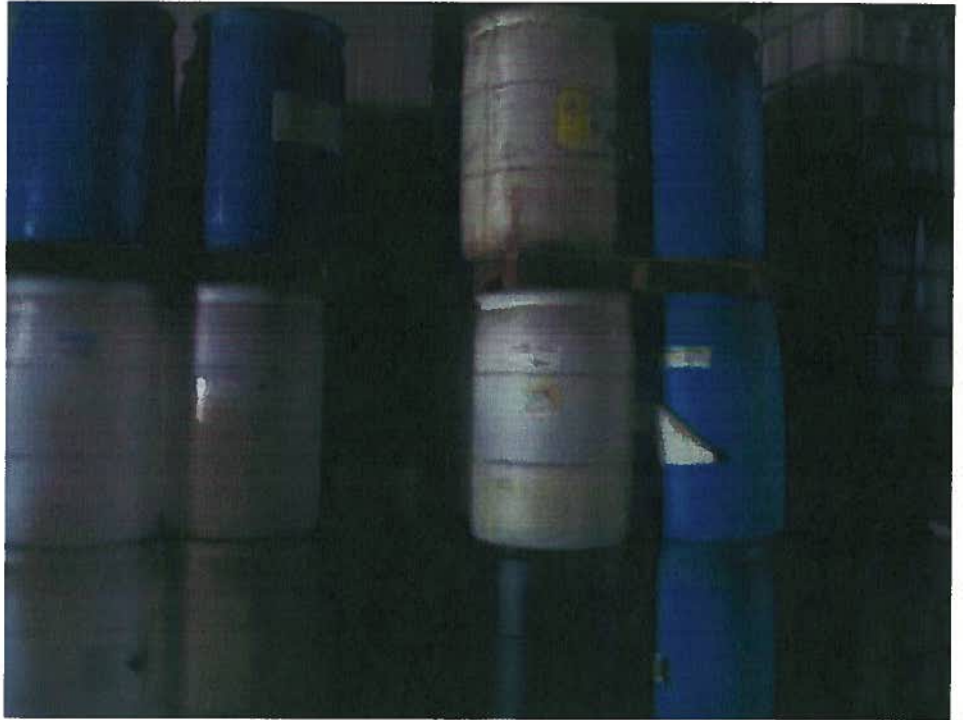
55-gallon containers were being stacked and stored next to the totes, along the South wall. The containers were described as being empty.

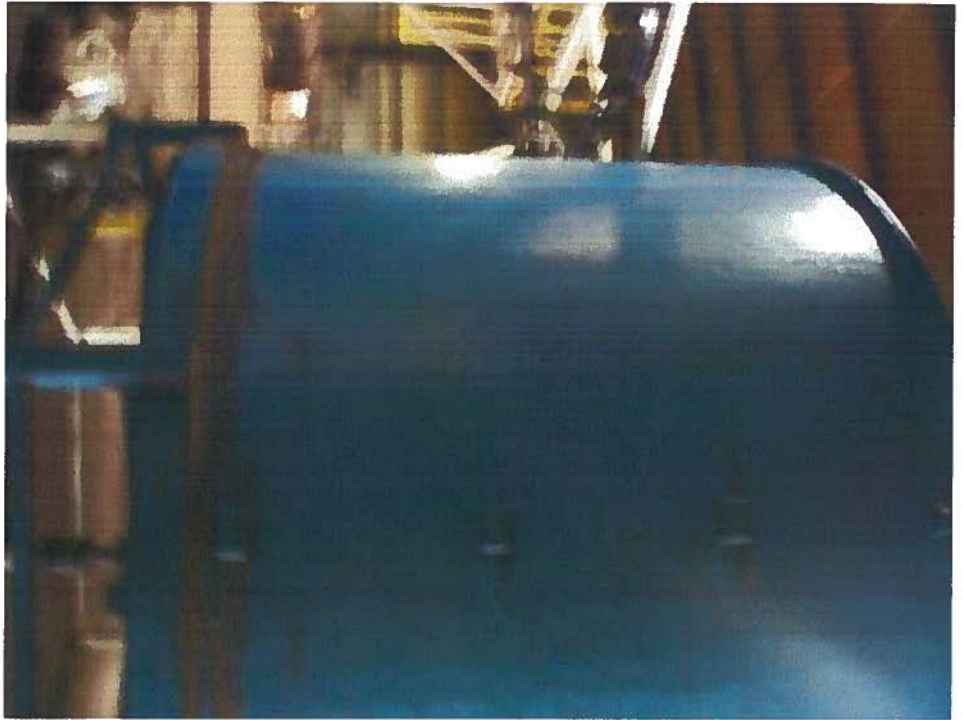
10,000 gallon E-coat line crash tank to be used in emergencies. The tank was described as empty; however will be used to collect E-coat line material(s) in cases of emergencies.

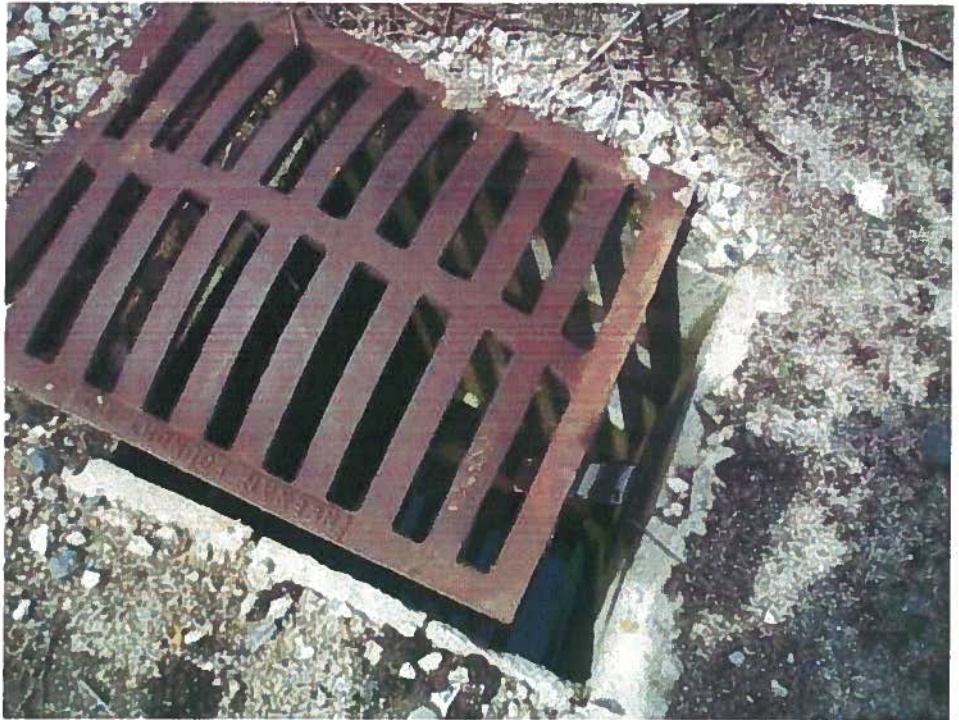
A storm water reservoir was located outside on the East side of the facility. The grid covering was not safely placed on the reservoir.

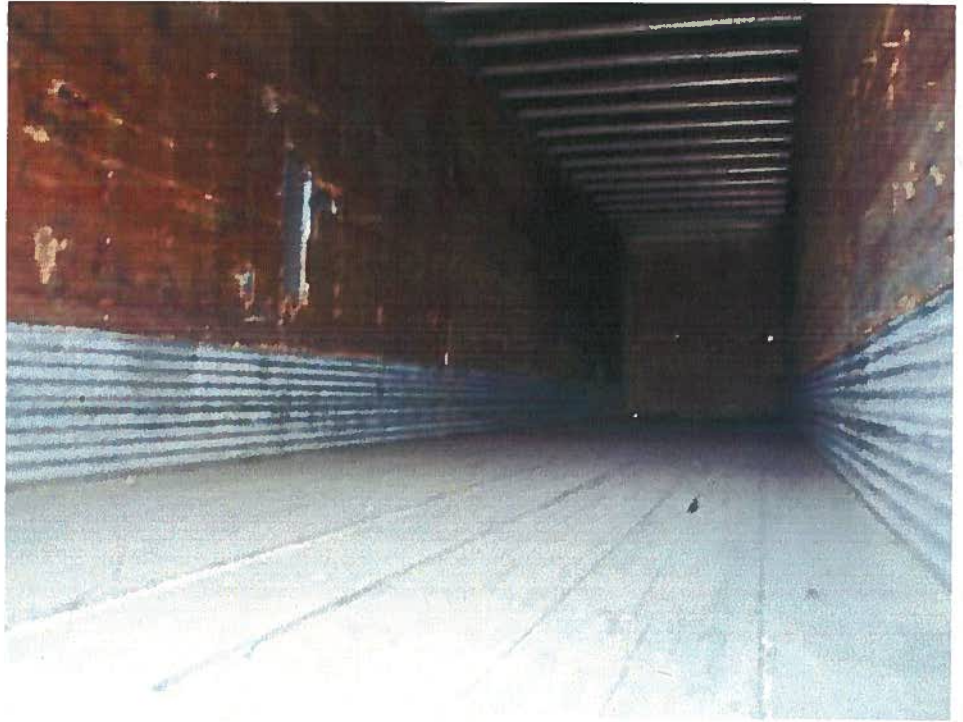
Four trailers were located outside on the East side of the facility. Trailer 2 was empty.

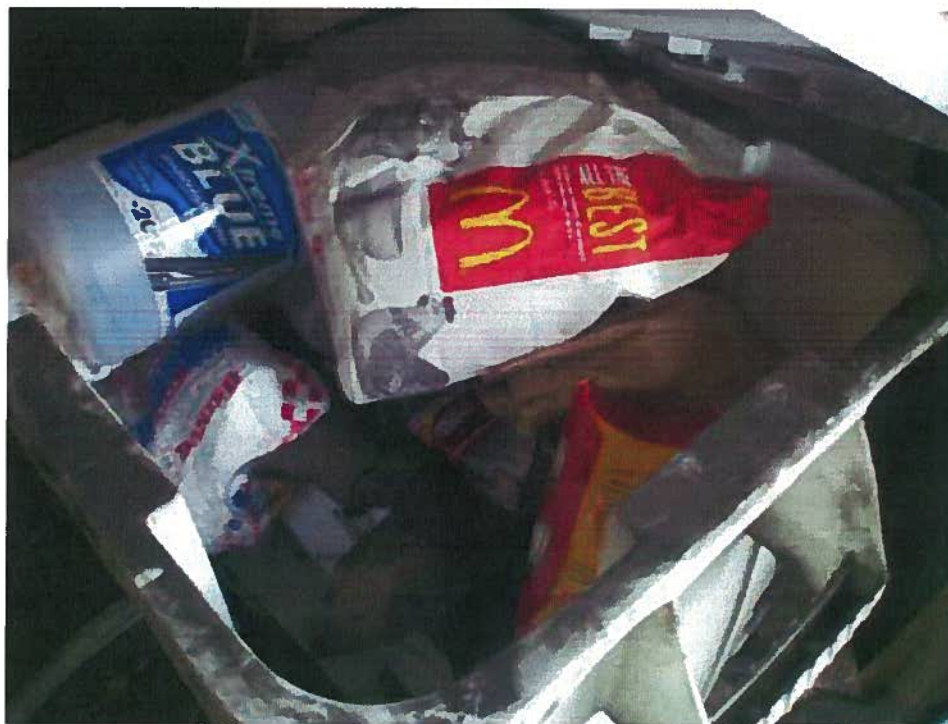
The spill kit was being stored on the East side of the facility, not near hazardous waste storage. The spill kit container was being used as a garbage can at the time of the inspection.

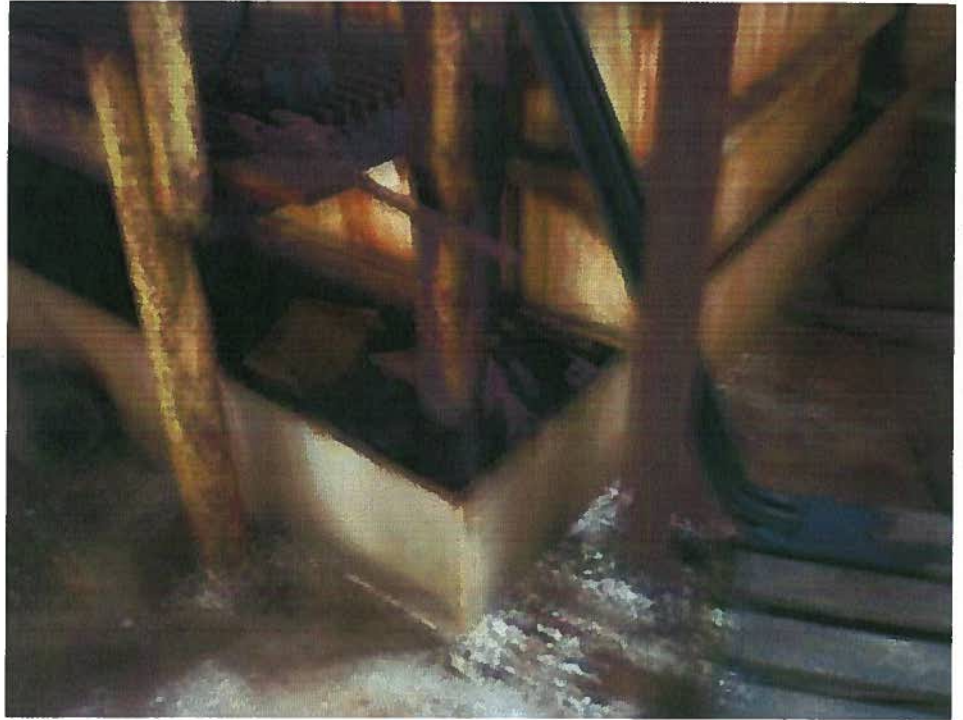
Barrel Row and Strip Line. Containment pit.

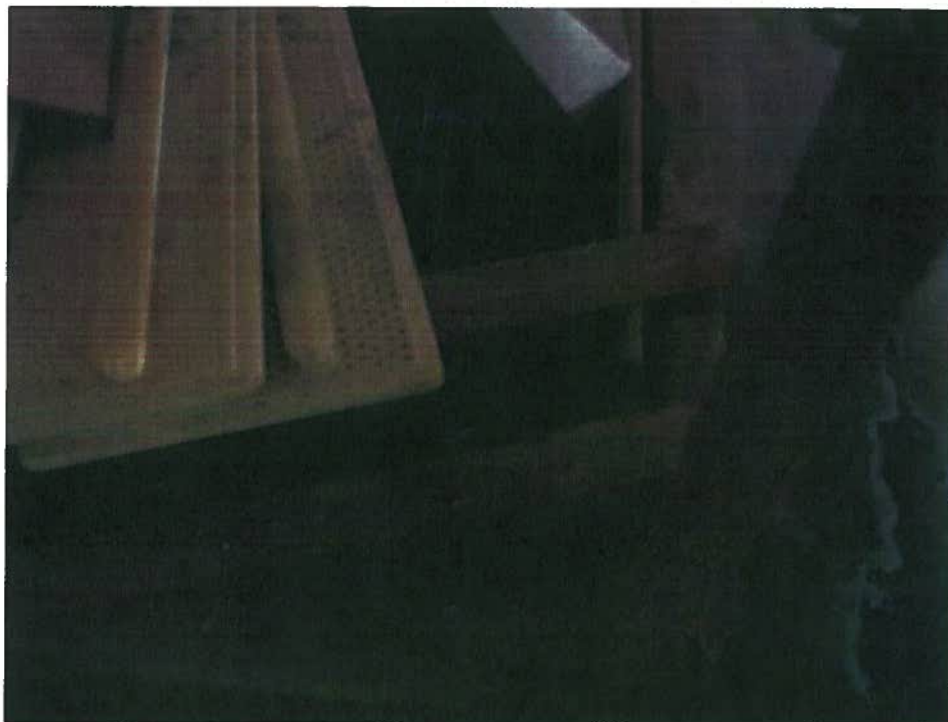
Barrel Row Line had been removed. Liquid and other material were located on the floor. Equipment was being stored within the area.

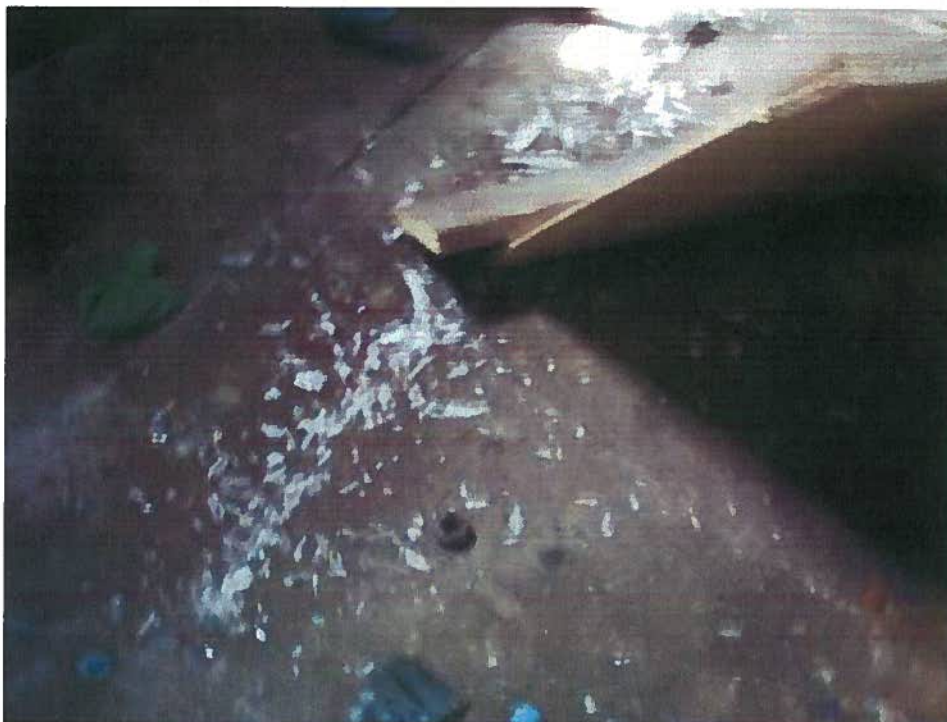
At the time of the inspection, Mid-City Plating was storing broken and crushed fluorescent light bulbs on the floor of the facility, next to the former Barrel Row Plating Line, with no documentation demonstrating the length of time that the light bulbs were located on the floor.

Broken fluorescent light bulb was located on the floor in the Barrel Row line room.

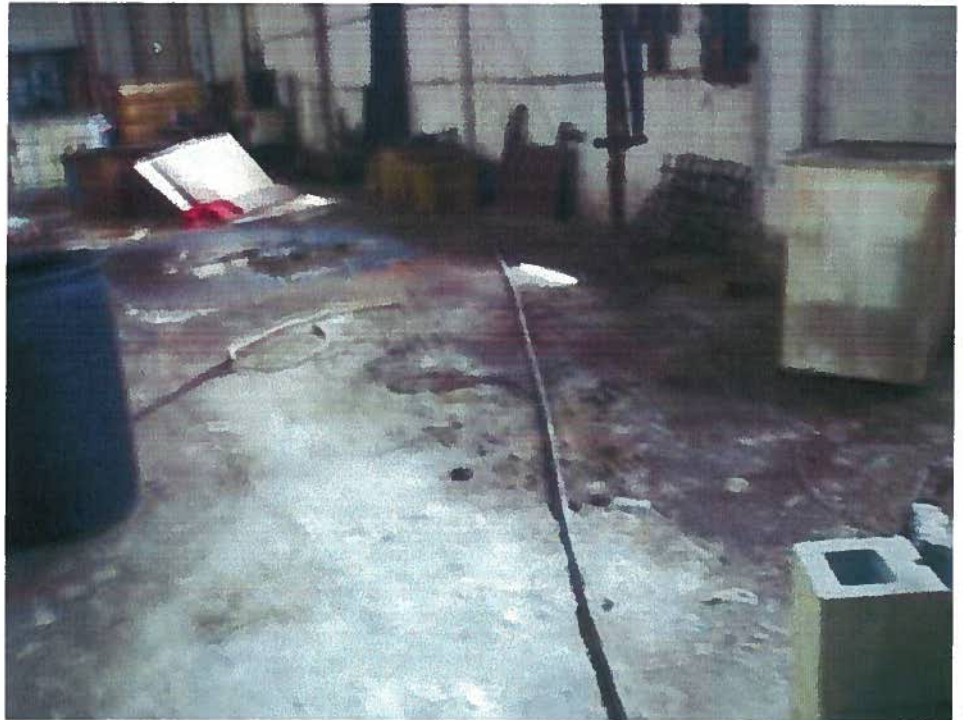
View of floor where the Barrel Row line was once in operation. Liquids and material were being stored on the floor. Various equipment was also being stored within the area.

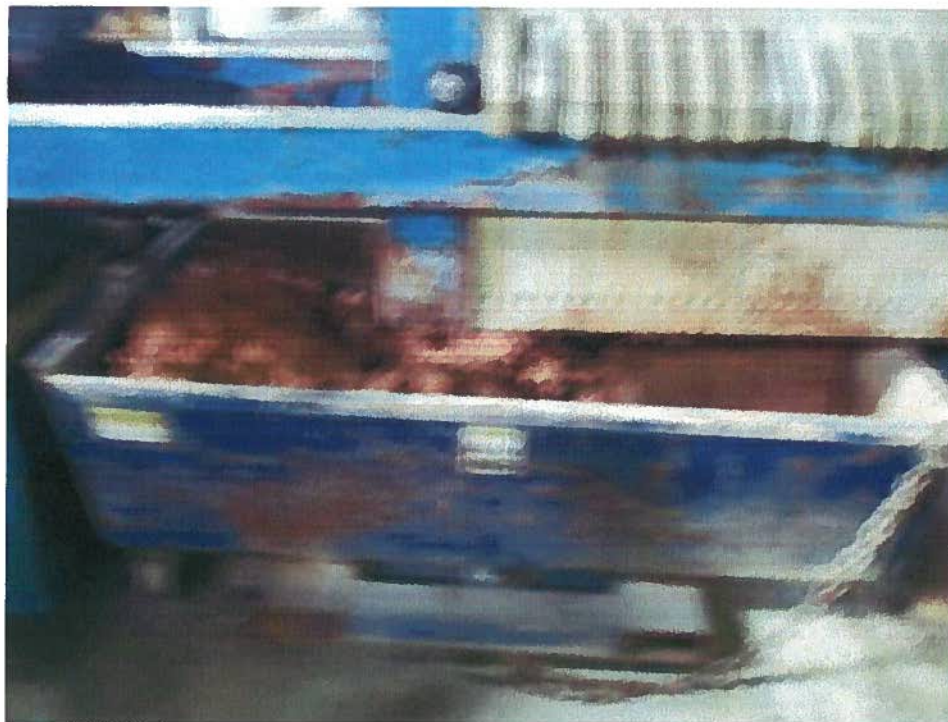
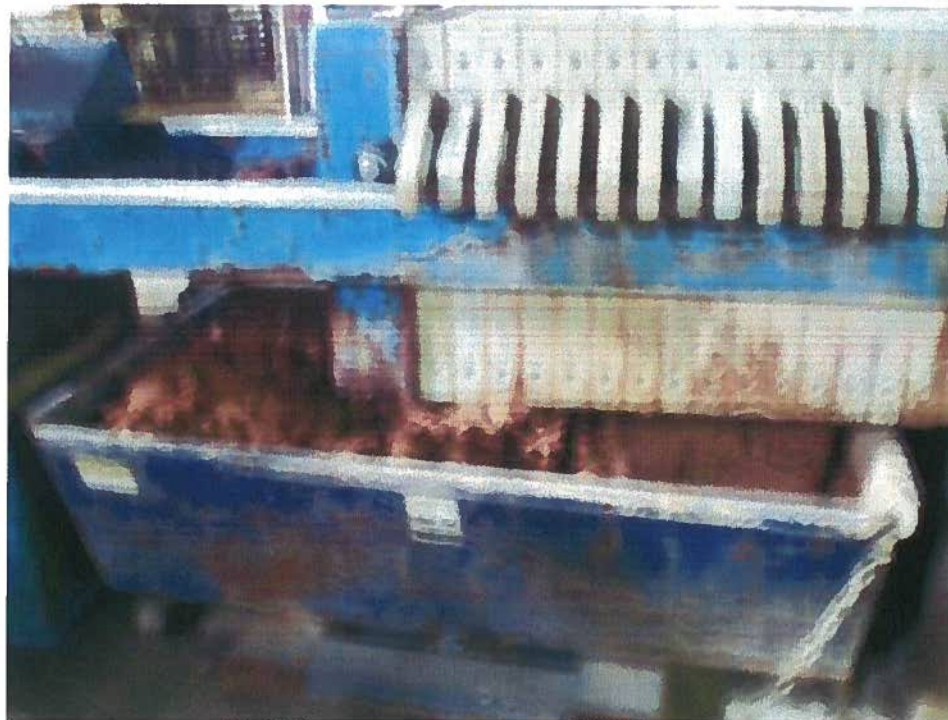
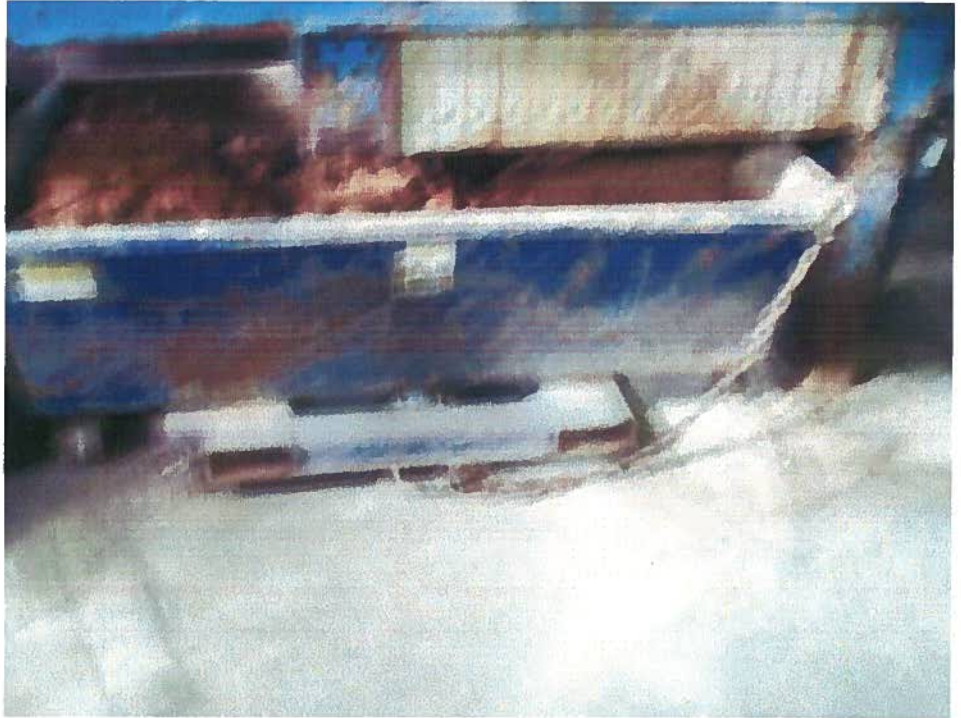
At the time of the inspection, Mid-City Plating was storing an approximately one cubic yard container of F006 hazardous waste underneath the waste water treatment unit (WWTU) filter press, without an accumulation date and without the words, "Hazardous Waste," marked on the container.

WWT unit filter press. Approximately 1 cubic yard. F006 waste water treatment sludge. Container was open, not labeled with the words, "Hazardous Waste," and not labeled with an accumulation date.

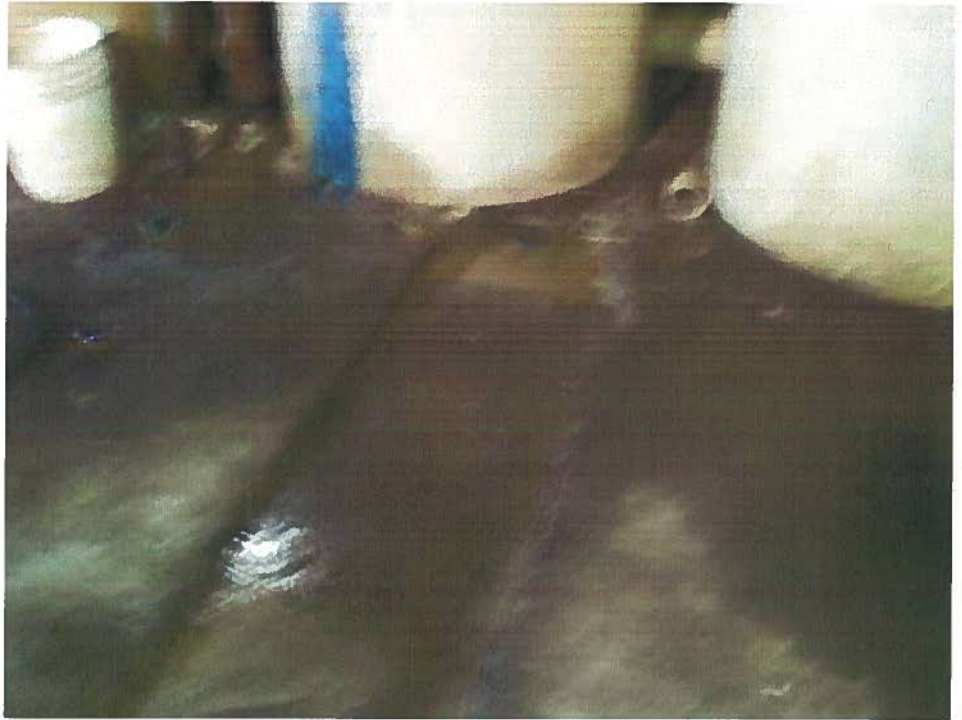
WWT unit. Liquid was located on the floor and within trench and sump pit located underneath WWT unit.

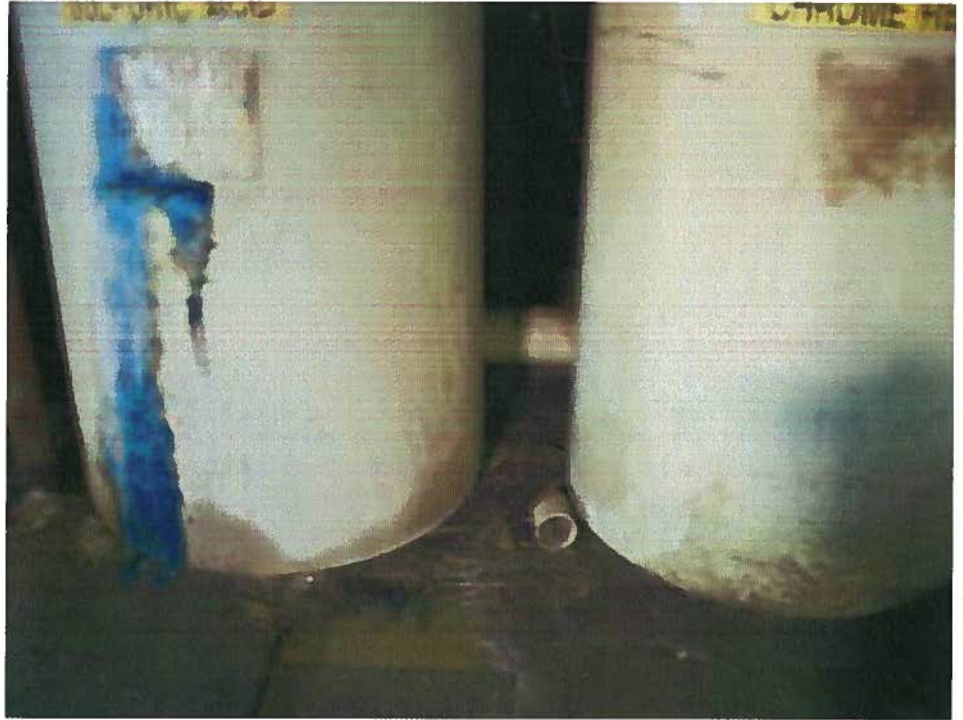
WWT unit. Liquid was located on the floor.  
Blue material appeared to have leaked on the  
outside of the tank labeled as, "Sulfuric  
Acid."

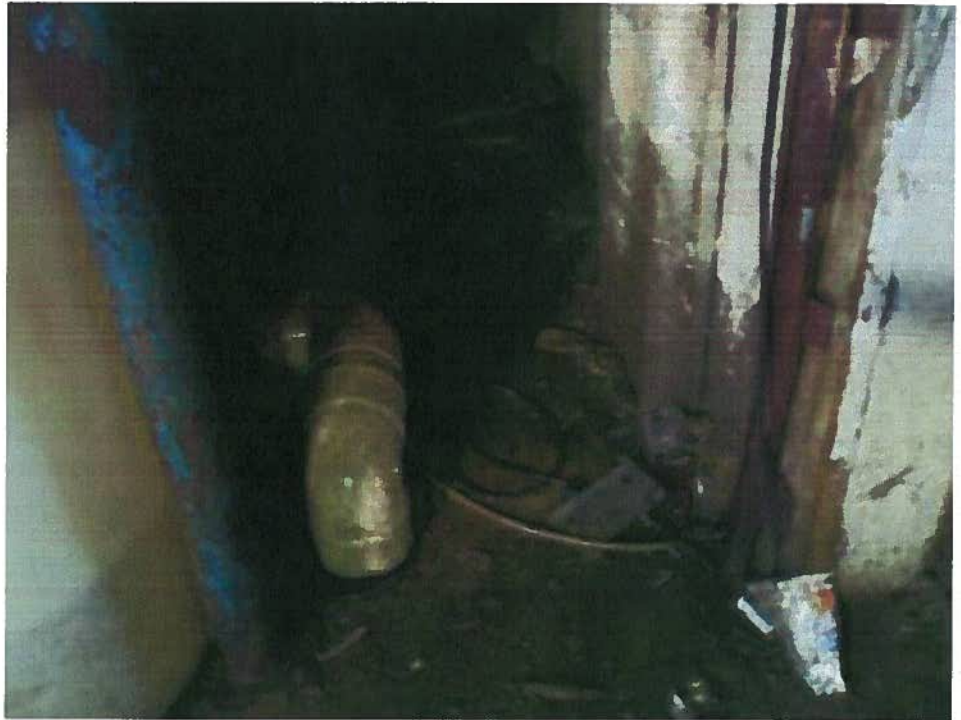
WWT unit. Liquid and debris were located on the floor. Trench and sump pit were located underneath the unit.
